HA-1344

134 Cornelia Ruff House
~~234~~ Baltimore Pike
Bel Air
Private

INVENTORY FORM FOR STATE HISTORIC SITES SURVEY

HISTORIC SITES SURVEY FIELD SHEET
Individual Structure Survey Form

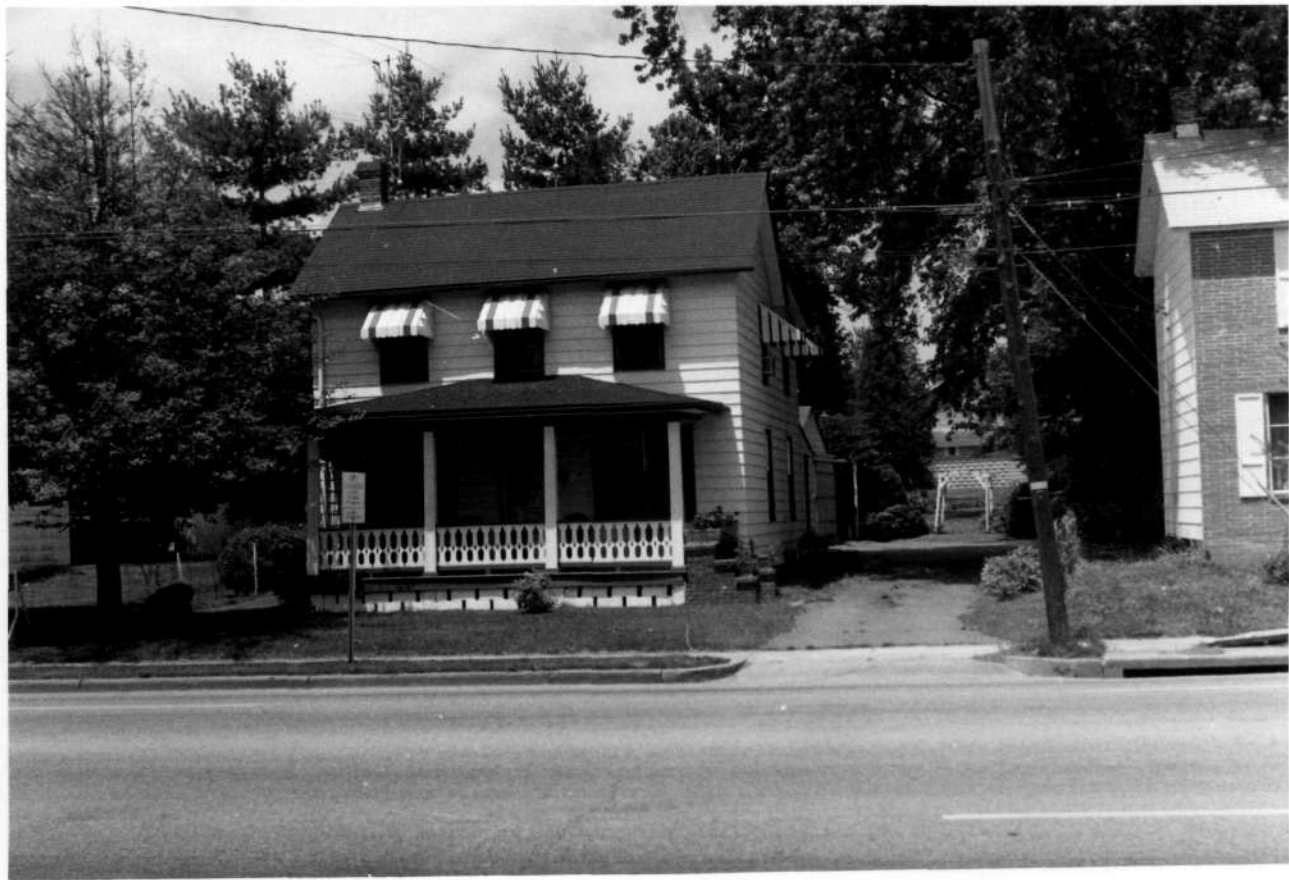
HA-1344

The distinctive feature about this house is the sawn Queen Anne balustrade to the front porch, its only decorative feature until the aluminum awnings were added.

House, #34 Balto Pike, Bel Air
S + e elev
